Re: **Inspection Summary/Violation Letter**
Yard 520 Landfill
Permit # 64-04/64-07
Town of Pines, Porter County

AGRICULTURAL AND SOLID WASTE COMPLIANCE

Yard 520 Landfill

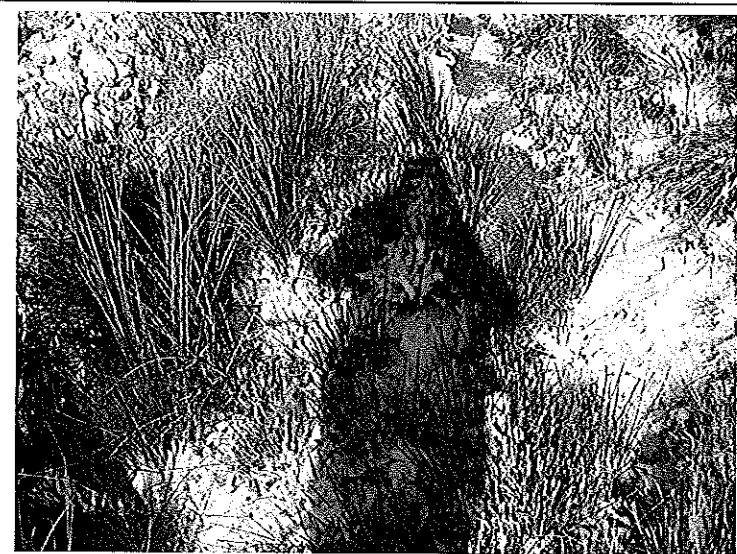
West Face of North Fill at the base of the fill there are about 3 large depressions filled with liquid that has started to freeze over. The depressions are believed to be areas of seepage from the landfill. This area is very close to a road and a major ditch to the south

--There are areas of depression on both the North and South fill that during rain storms could cause ponding on the fill. There are also the areas on the West side of the North fill where water has ponded and started to freeze over near the base of the fill. These areas need to be addressed so that ponding of water does not occur.

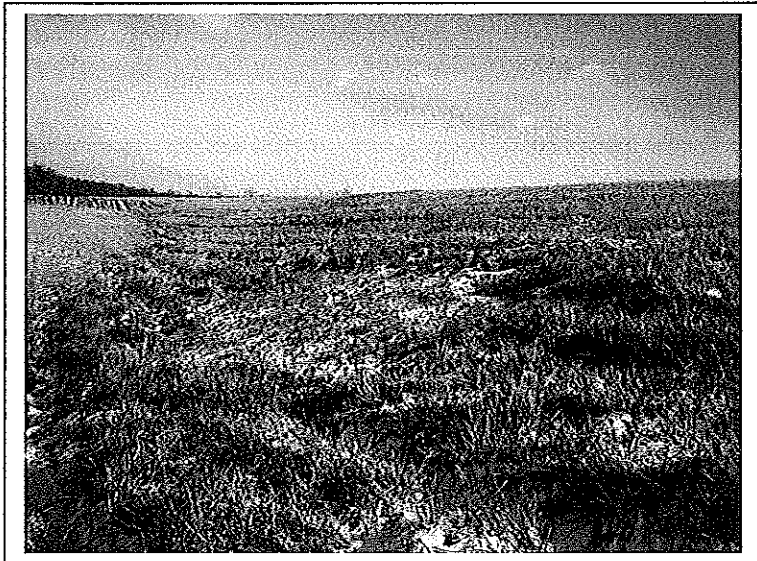
Area on the North slope of the North fill where the vegetation has been disturbed possibly a breakout point. There is a slight depression lower than the grade of the slope and all vegetation in this circular area has been disturbed.

329 IAC 10-31-1(1) and (2) Owners or operators of a restricted waste site Type I and Type II and nonmunicipal solid waste landfills shall maintain the facilities during the post-closure period in a manner that: (1) minimizes the need for further maintenance (2) controls post-closure escape of waste, waste constituents, leachate, contaminated precipitation, or waste decomposition products to the ground or surface waters or the atmosphere ---There is a noticeable seepage outbreak on the West slope of the North fill. This area has about 3 moderately sized depressions where liquid is present and has started to freeze. The vegetation in this area indicates that the area is normally moist enough to allow hydrophilic plants to grow. The fact that the area is always wet is of great concern that this would be an area where seeps have/will occur. This area is also very close to a road and major ditch posing a threat to people and waters of the state. This needs to be controlled in order that no leachate/seepage occurs nor does it leave the fill area.

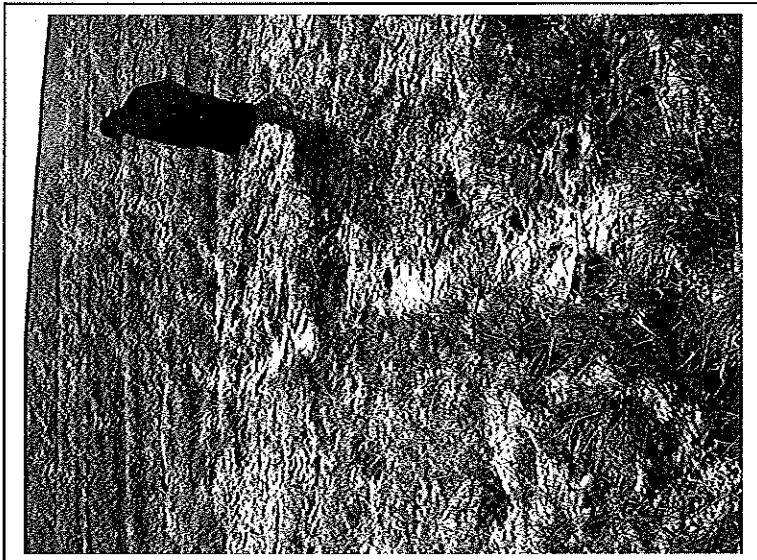
The North slope of the South Fill. A gully in the cap where possible seepage/leachate could be breaking out.

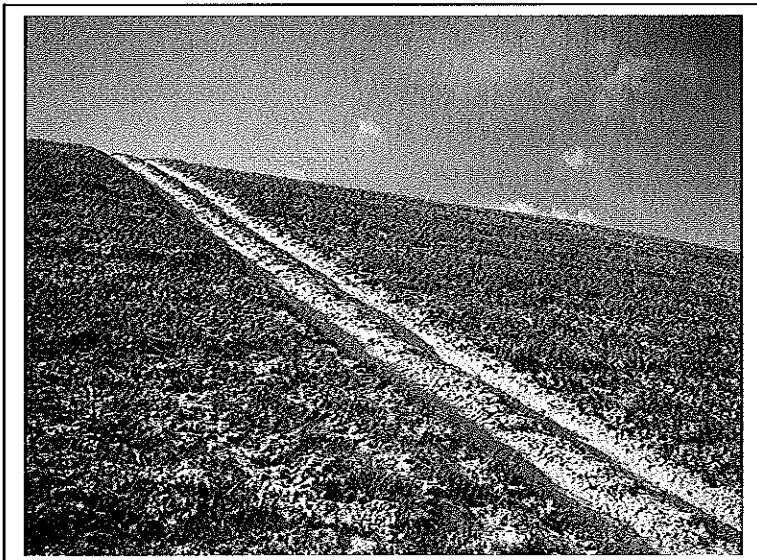
Large depressions on the East slope of the South fill showing tire tracks going all the way up the fill. There were numerous tracks all around the landfill but these were the most prominent. It looked like this was the access site being used by unapproved vehicles (ATV's) onsite

--Currently there is not adequate access control to yard 520 as can be seen by some heavily used ATV tracks that cross both the North and South fill. The owner stated that the tracks are from trespassers. Access to the site needs to be restricted in order to maintain the integrity of the cap. At this time the ATV activity is causing compaction and depressions in the cap.
